North Water Street Former MGP Site Remediation Project Season 2 Update

Remediation Project Site

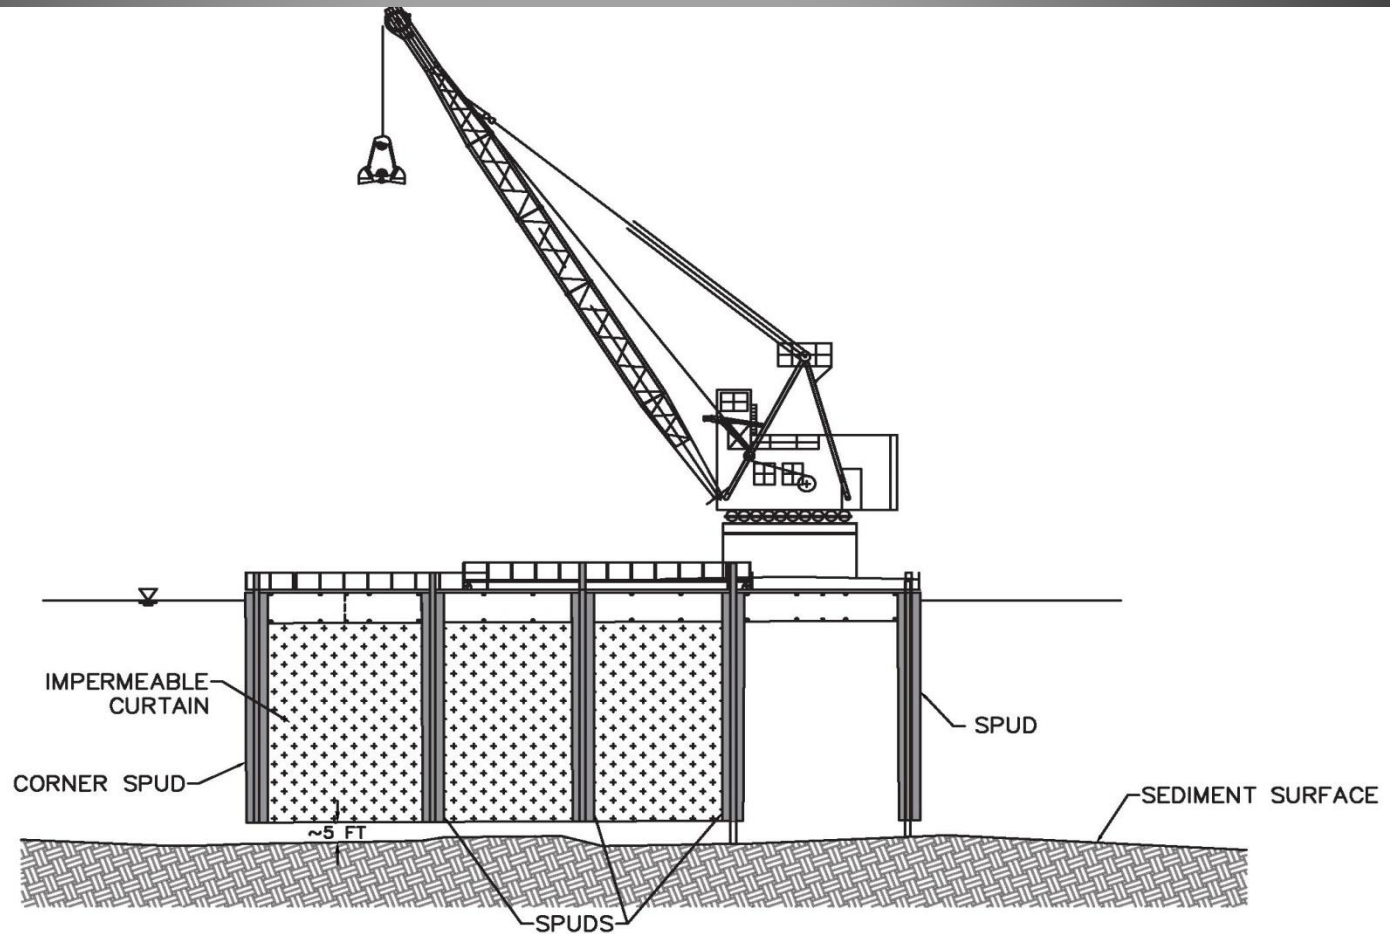
Fortified "Moon Pool" Operation

MOBILE SUSPENSION CONTROL SYSTEM SETUP
